SAJA
SERIES

SERVICE MANUAL

R-32 Split-Type Air Conditioner

ISA32181/OSA32181

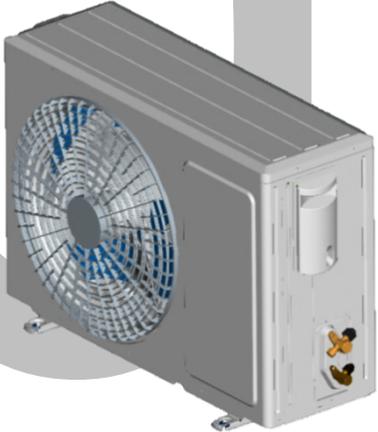
| Part | Procedure | Diagram |
|---|---|---|
| 1 | Turn off the power , remove connection screws among top cover plate, front panel and right side panel, then remove the top cover. | |
